# Manhole Inspection Summary

Manhole # S17K1\_009MH

Insp Date: **4/30/08 1:06 PM**

**Location** Address: **3201 mardel av**

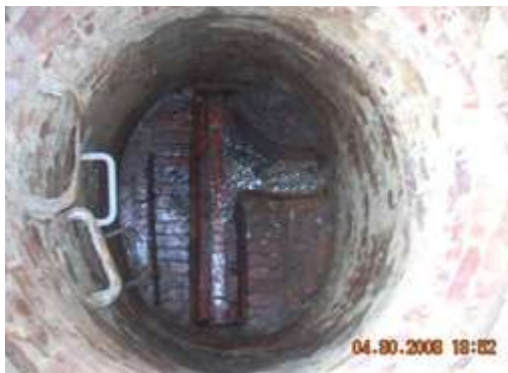
misc

Channel Debris

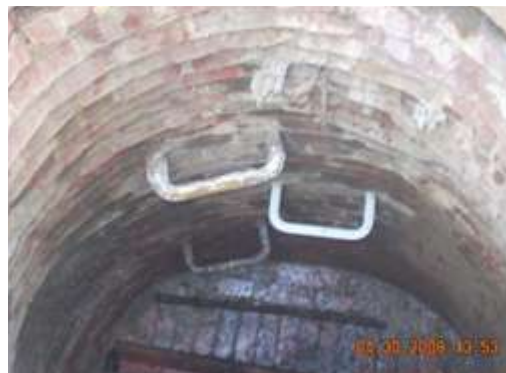
Defect 2

Infiltration: ☐ None ☒ **Joint** ☐ Cracks ☐ Mortar ☐ Roots ☐ Wall

Infiltration: ☐ None ☐ Joint ☐ Cracks ☐ Mortar ☐ Roots ☒ **Wall**

Count: **3** Missing: **1** ☒ **Corroded**

corroded steps, infiltration @ chimney/frame joint, infiltration @ corbel wall

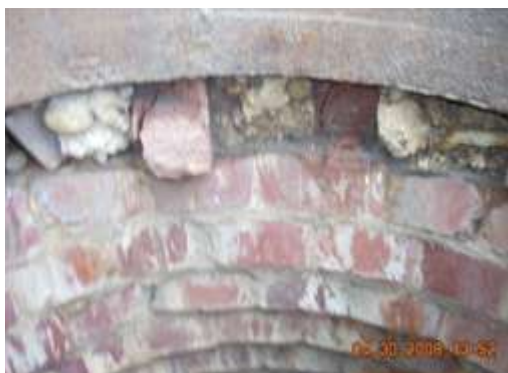
Defect 1

Condition: ☐ Sound ☐ Cracked ☐ Root Intrusion ☐ Loose Brick ☒ **Deteriorated**

deteriorated chimney

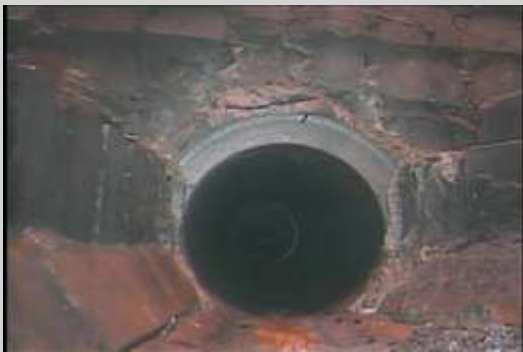
12 O'Clock Outflow

Pipe Height: **8.4** (in.) Rod and Bar (Angled)  
Pipe Material: **Clay** ☐ Pipe Lined  
Invert Depth: **9.05** (ft.) Flow Characteristics: **Slow**  
Deposits: ☒ None ☐ Mud ☐ Sludge ☐ Debris ☐ Grease  
Silt Depth: **0** (in.) Deposits Extent:  
Infiltration: **None** Pipe Seal Cond: **Cracked**

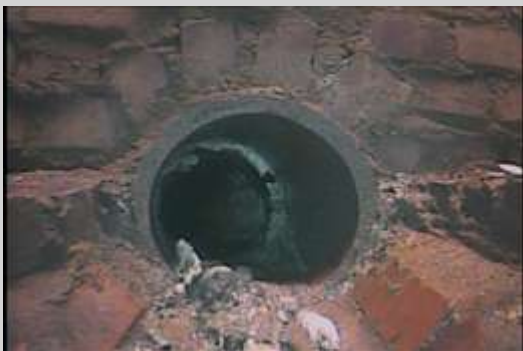
3 O'Clock Inflow

Pipe Height: **8.4** (in.) Rod and Bar (Angled)  
Pipe Material: **Clay** ☐ Pipe Lined  
Invert Depth: **8.65** (ft.) Flow Characteristics: **Slow**  
Deposits: ☐ None ☐ Mud ☒ **Sludge** ☐ Debris ☐ Grease  
Silt Depth: **1** (in.) Deposits Extent: **Light**  
Infiltration: **None** Pipe Seal Cond: **Sound**
